Holiday Blue & Express Red (Zone Y and Z) Long-term Car Parks

The Holiday Blue Flood Risk Assessment (FRA)

daa

March 2018

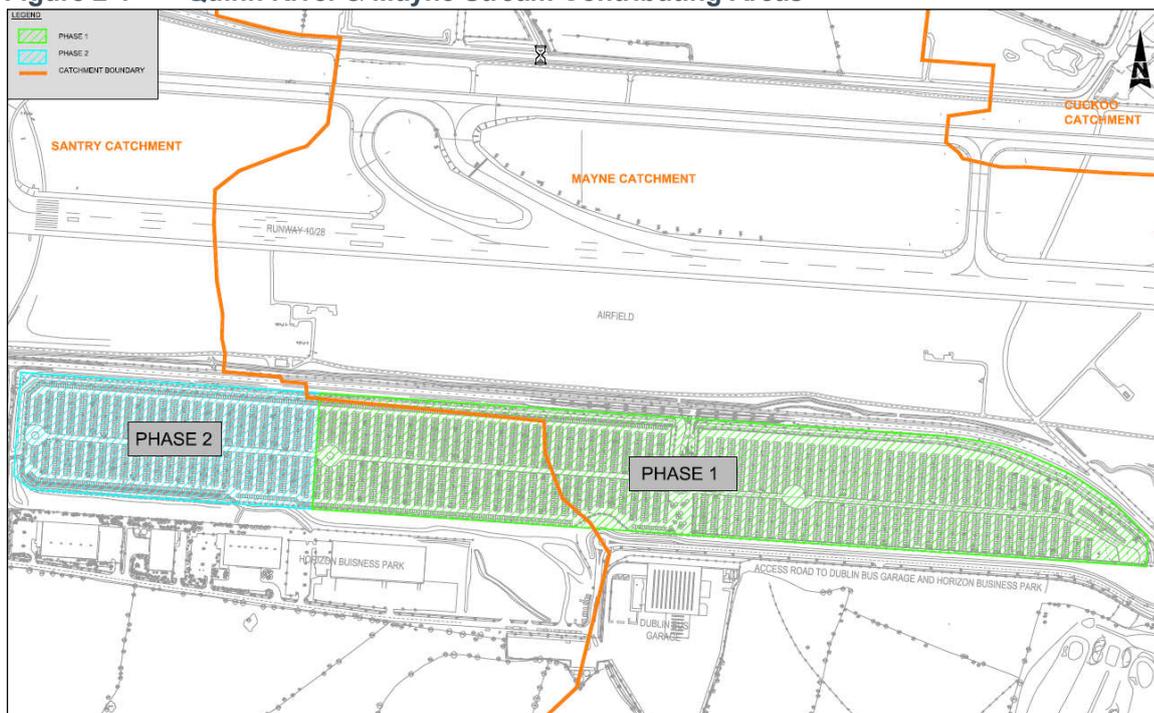
Figure 2-1 Quinn River & Mayne Stream Contributing Areas

The most immediate hydrological features in the vicinity of the site are the Quinn River and the Mayne Stream. The extent of both catchments within the existing carpark are shown in Figure 2-1 below:

The Quinn River, which runs along the south-western boundary of the existing carpark, is a tributary to the Santry River. The catchment area upstream is approximately 2.5km², which consist largely of agricultural lands, single developments and the western portion of Holiday blue Carpark. The Quinn River runs from north-west to south-east to where it discharges into the Santry River approximately 2.5km downstream. The Santry River flows to the south east through Santry and outfalls into Dublin Bay at Raheny adjacent to St. Anne's Park approx 8.5 kms away.

The Mayne Stream, which runs along the northern and eastern boundary of the existing carpark, flows eastwards and ultimately discharges into Baldoyle Bay along the Mayne Road approximately 8.6 km downstream. The Mayne River drains the eastern portion of Holiday blue Car park, a large portion of the nearby Runway 10/28 and surrounding green spaces.

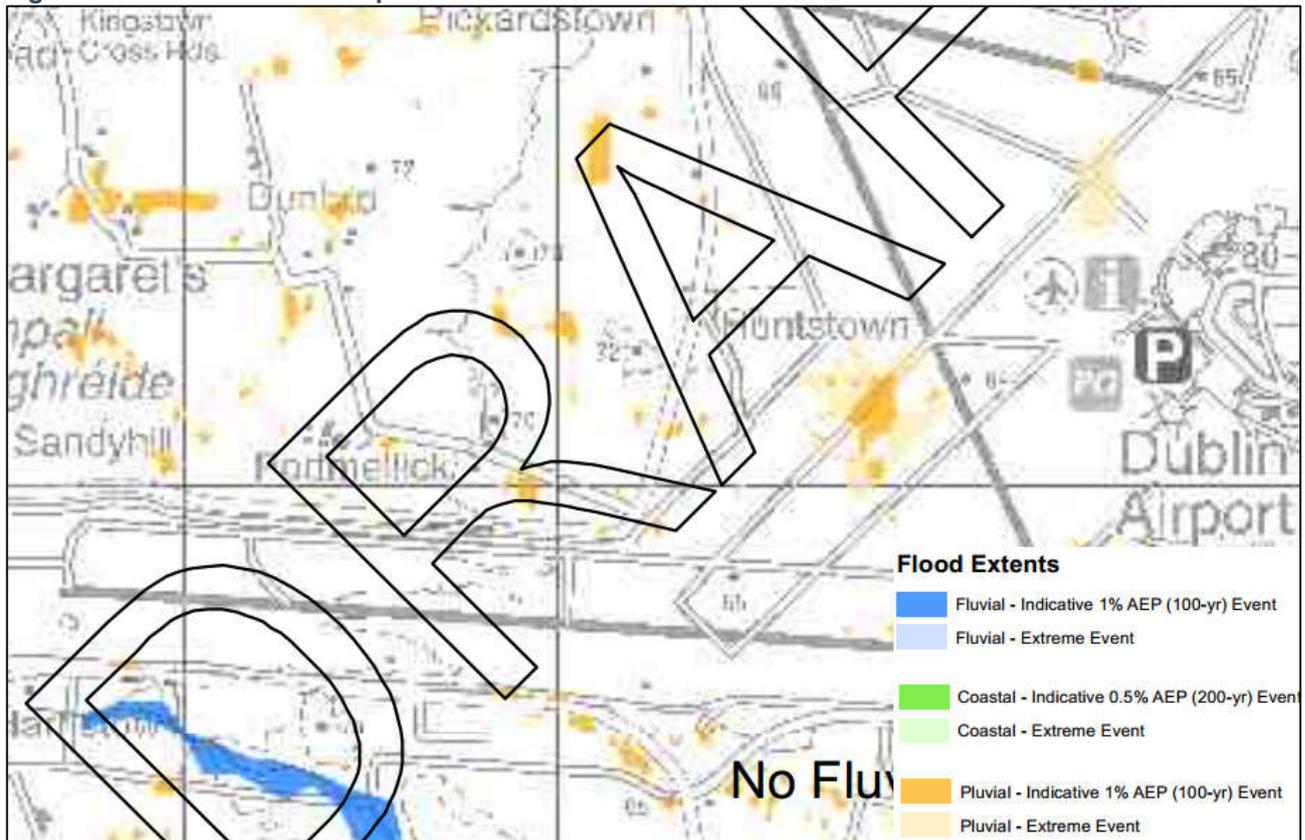
Figure 4-1 OPW PFRA Map - Quinn River

Draft Preliminary Flood Risk Assessment (PFRA) Maps have been produced for the whole country by the OPW. Figure 4-1 below, extracted from OPW PFRA Map number 2019/MAP/256/A, and illustrates predictive flood zones in the vicinity of the site

Figure 4-1 above indicate the predicted floodplain encroaching the southern boundary of the existing carpark. It should be noted that the predicted extent of the flooding shown on these maps was developed using low resolution digital terrain model (DTM) and the illustrated flood extents are intended to be indicative only.

The OPW and Fingal East Meath CFRAM maps indicate a potential fluvial flood risk to the existing Holiday blue carpark from the Quinn River. Both maps show the predicted 1 in 100 year and 1 in 1000 year predicted flood extents breaches the boundary of the existing carpark. The existing carpark is classed as water compatible under the OPW guidelines “*The Planning System and Flood Risk Management – Guidelines for Planning Authorities*’ DOEHLG 2009”. Hence the fluvial flood risk posed by the Quinn River is deemed to be acceptable provided that in event of flooding the emergency measures are place to mitigate the impact on human health and environment.

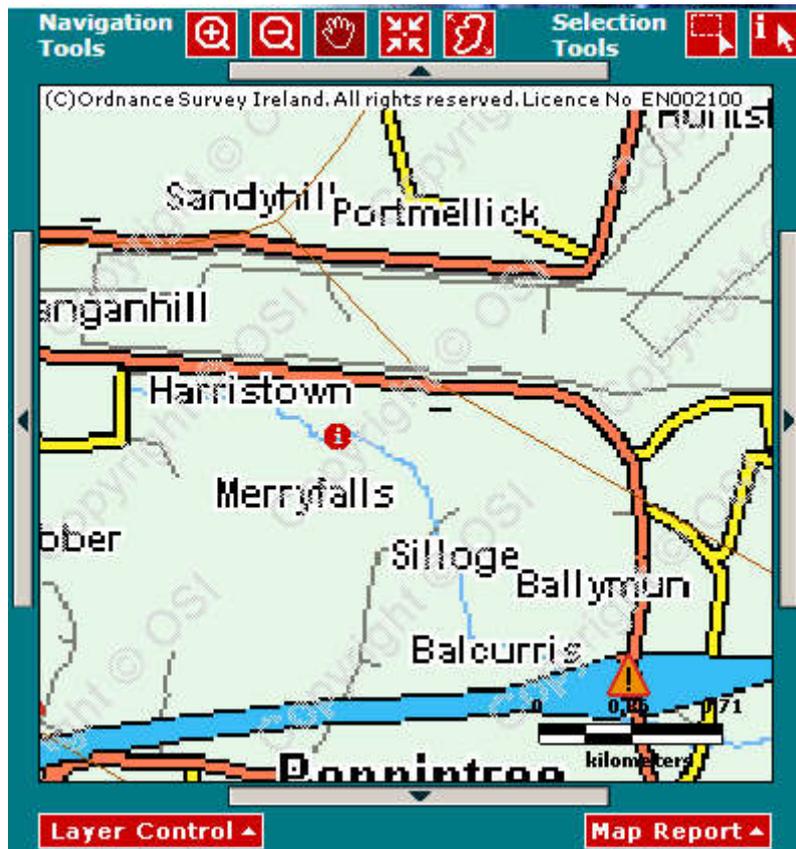
Figure 4-2 OPW Flood Hazard Map

The OPW Flood Hazard Mapping website (www.floodmaps.ie) was consulted in relation to available historical or anecdotal information on any flooding incidences or occurrences in the vicinity of the site. Figure 4-2 below shows mapping from the Flood Hazard Mapping website in the vicinity of the study area:

Figure 4-2 above does not indicate flooding in the immediate vicinity of the existing carpark. The nearest reported flood event identified was at the South Parallel Road Junction with the M50 approximately 1.5km downstream of the existing site. This reported flood event occurred over the period of 13th-15th November 2002 and was exacerbated by a culvert on the Quinn River surcharging which contributed to the flooding of adjacent greenfield sites. There was no flooding at the existing carpark during this event.

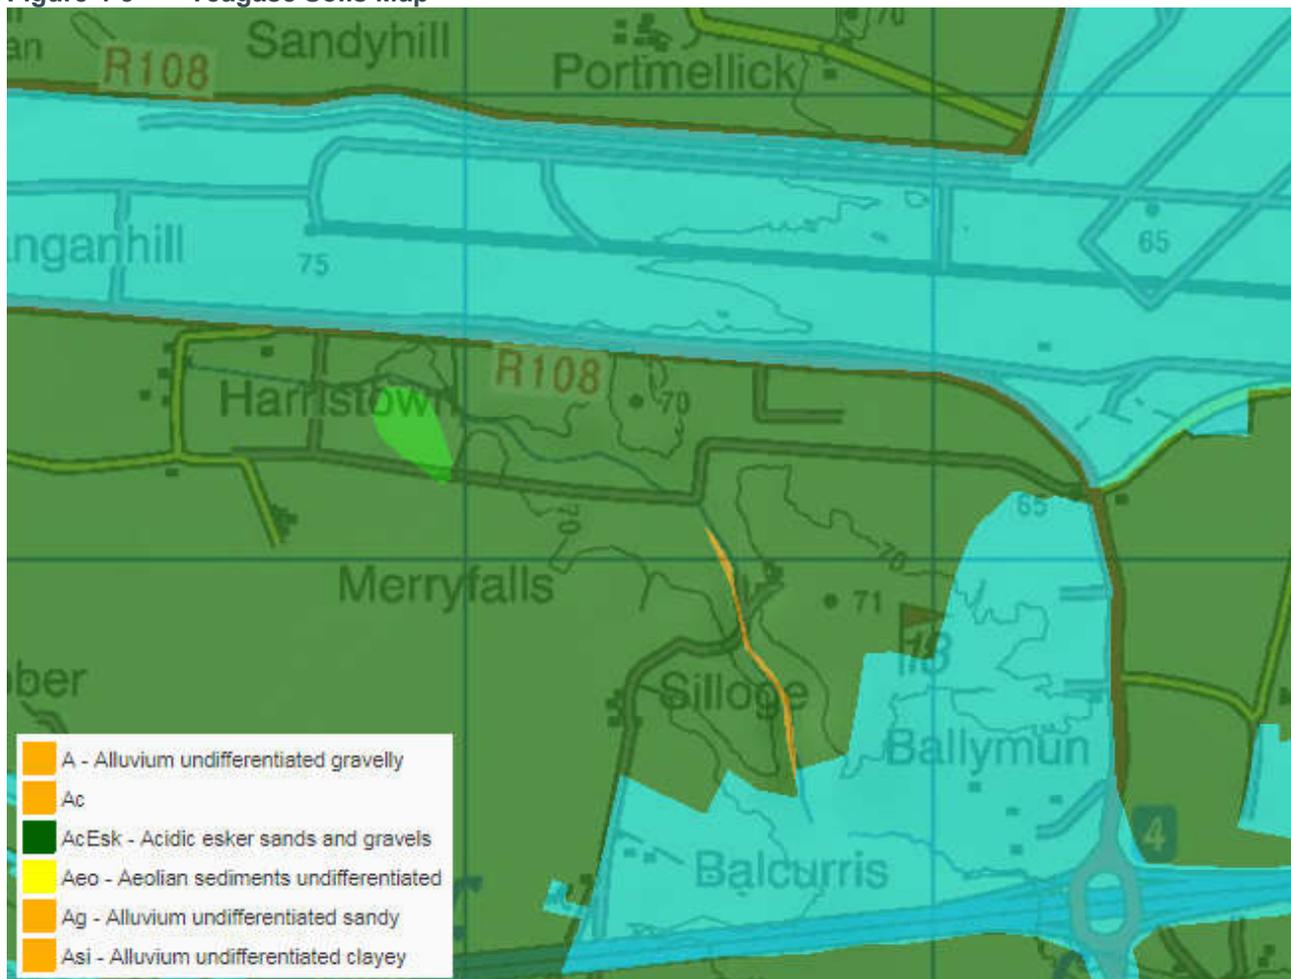
Figure 4-3 Teagasc Soils Map

The Teagasc Soils maps were consulted to determine the presence of alluvium deposits in the vicinity of the site. Deposition of alluvium deposits can be an indicator of areas which have flooded in the recent geological past.

Figure 4-3 below show the sub-soils mapping for the site of which does not indicate alluvium deposits within the immediate vicinity of the existing carpark.

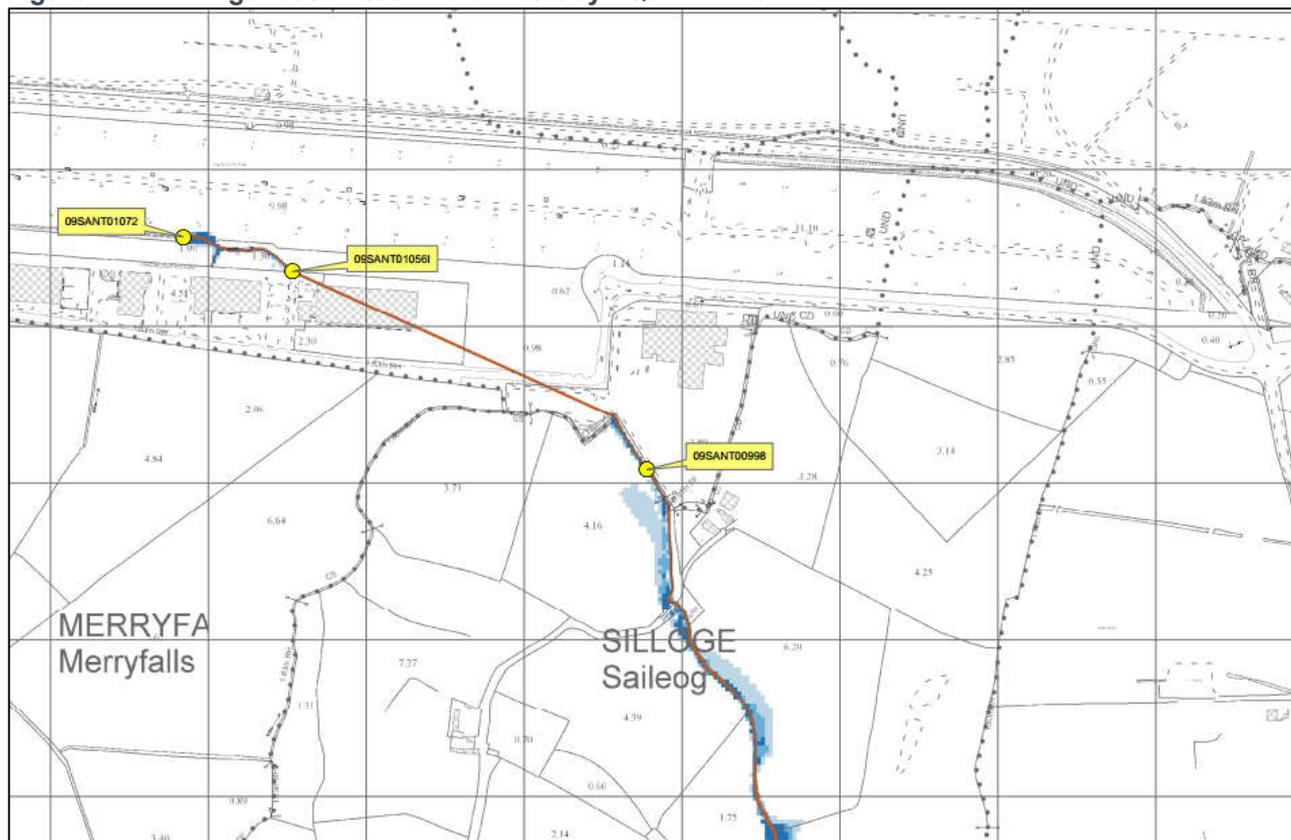
Figure 4-4 Fingal East Meath CFRAM Study - Quinn River

A detailed flood risk extents map produced for Quinn River adjacent to the southern boundary of the existing carpark is shown in Figure 4-4 below.

Figure 4-4 above show the 1 in 100 year and 1 in 1000 year predicted flood extents encroaching the southern boundary of the existing carpark.

The potential fluvial flood risk to the existing Holiday blue car park from the Quinn River was detailed as part the Fingal East Meath CFRAM Study. The study indicates the predicted 1 in 100 year and 1 in 1000 year flood plain breaches the boundary of the existing Holiday blue Car park. The existing carpark is classed as water compatible under the OPW guidelines as discussed in Section 5 above.
